## Fairway Buoy No.5 – Unlit

Captain Michael McKenna | Harbour Master | 23 February 2024

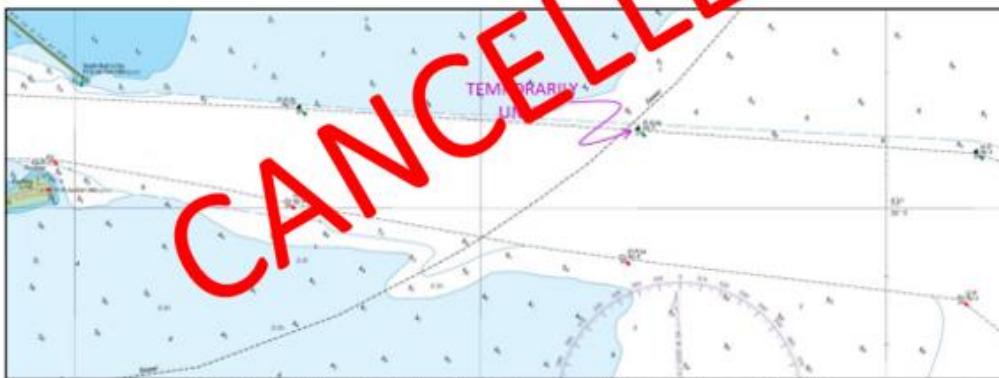
Extract of BA1447 Plan B - Not For Navigation © Crown Copyright. Reproduced by permission of the Controller of His Majesty's Stationery Office and the UK Hydrographic Office [www.GOV.UK/UKHO](http://www.GOV.UK/UKHO)

Masters, Warranted Pilots, Holders of Pilotage Exemption Certificates, Owners, Operators and Agents of all Vessels navigating within Dublin Port are hereby notified that starboard fairway lateral mark Buoy No.5 is reported as unlit.

We will attend the buoy to repair/replace the light as soon as possible.
